Pre-Purchase Inspection

01826-21

██████████ of ██████████
Inspect on the 2nd February & 26th April 2021
the Troll 32' – Wooden Norwegian Motor Sailor
at Bell Boats, Brundall, Norfolk
Purpose Pre-Purchase Inspection
Report ref # 01826-21

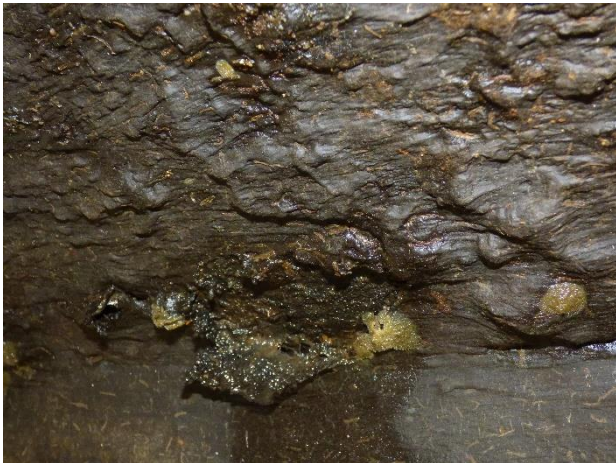
The underwater surfaces have been covered with a black rubberised coating and are in poor condition. The rubberised coating has lifted away from the planking in several places. These places retained water much like a blister.

Blisters viewed on underwater surfaces

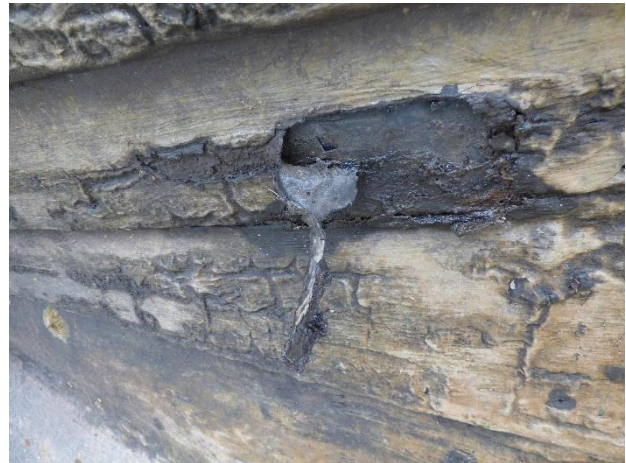
Blister head removed

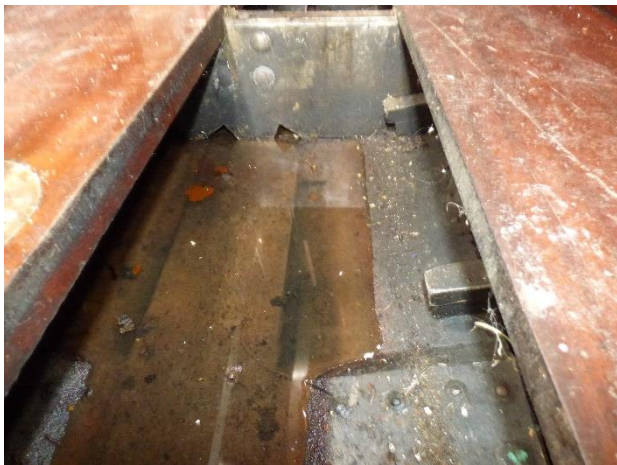
Water found throughout the bilge space. Bilge pump ran but did not pump water.

Retaining water in the bilge spaces will lead to overall structural (wood) degradation and potential rot.

Retained bilge water

- Maintain bilges in a clean, painted and dry condition.

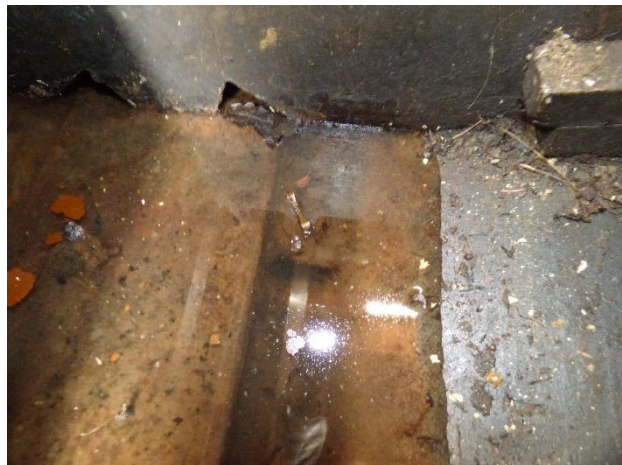
Bronze drain plug viewed internally, used by existing owner to drain bilges when boat is lifted ashore for any reasonable length of time.

Bronze drain bung viewed internally

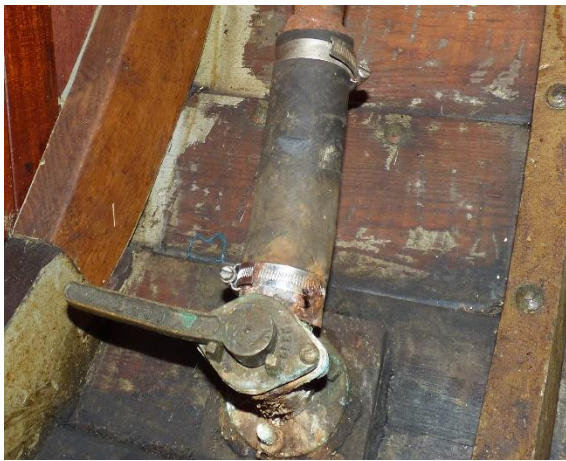
Corroded J-clip on sink waste

Blakes valve J-clip is starting to corrode.

- Service all seacock valves where necessary and fit second J-clips.
- Replace corroded J-clips plus improved maintenance.
- Seacock valves not bonded; *See notes*

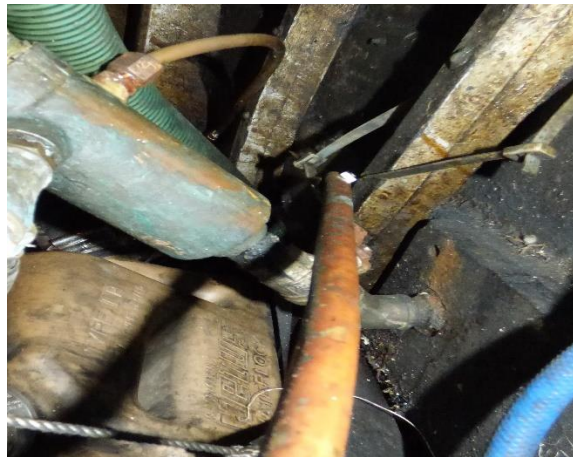
Engine seacock valve installation

Fit 2x J-clips to pipe work on all seacock valves.

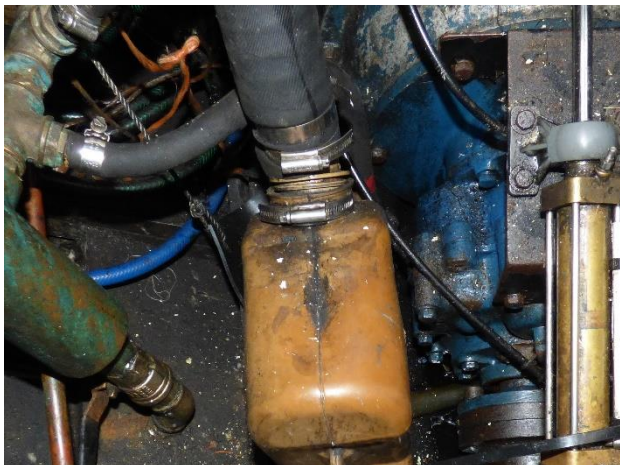
Outlet elbow appears to have become detached.

Vetus exhaust water lock / muffler outlet fitting appears to have become detached.

Exhaust water lock / muffler outlet fitting

- Improved maintenance.
- Investigate further the detached outlet fitting in the water lock / muffler.
