Pre-Purchase Inspection

01826-21

██████████ of ██████████
Inspect on the 2nd February & 26th April 2021
the Troll 32' – Wooden Norwegian Motor Sailor
at Bell Boats, Brundall, Norfolk
Purpose Pre-Purchase Inspection
Report ref # 01826-21

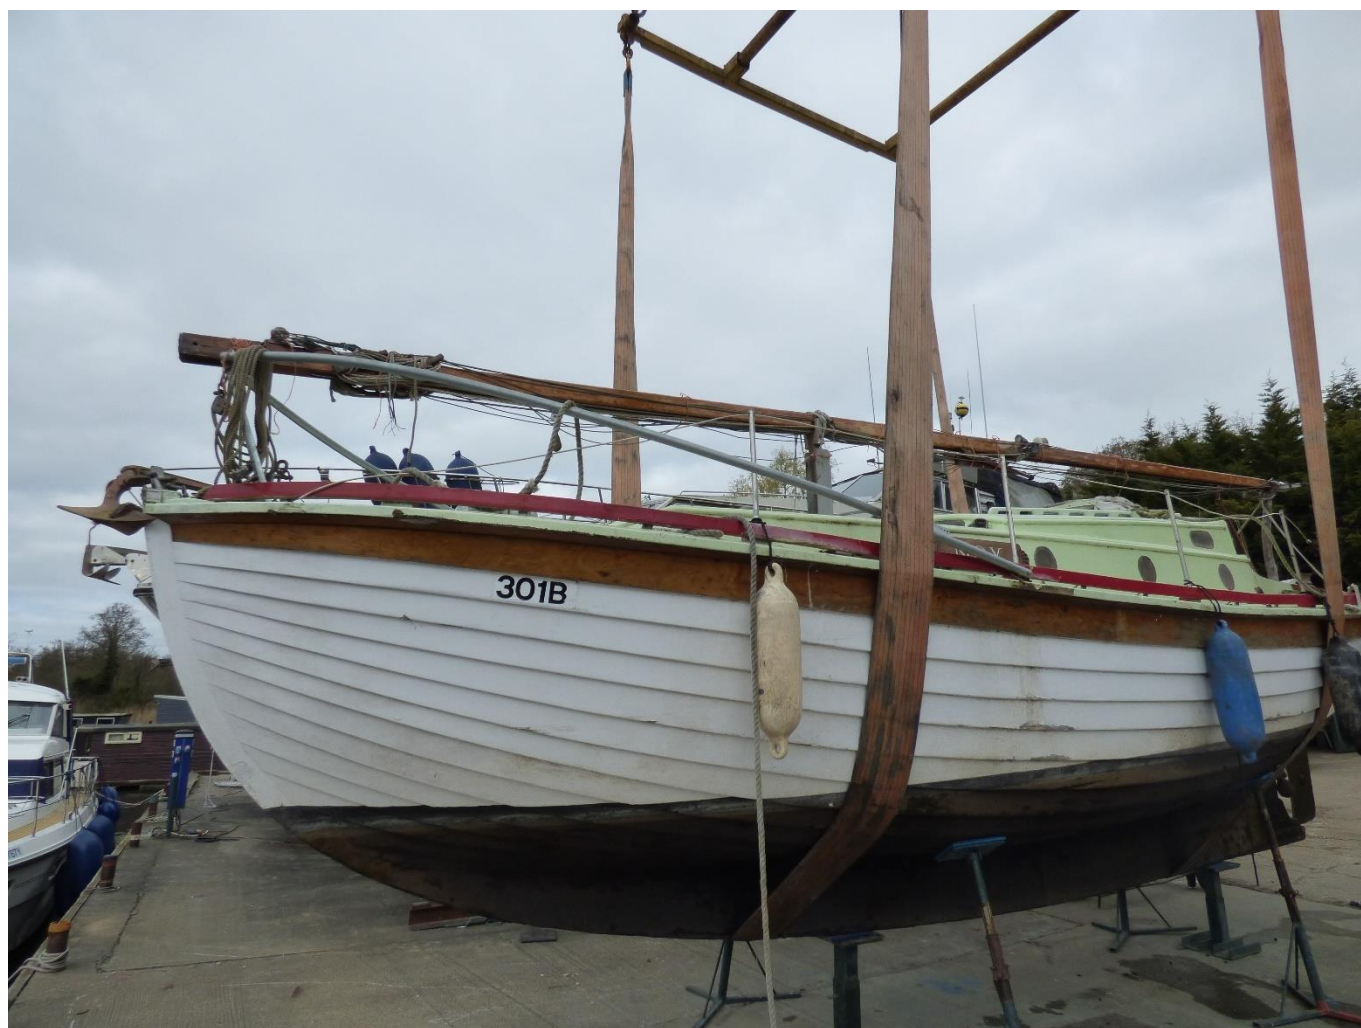
The hull is fouled

The underwater surfaces have been covered with a black rubberised coating and are in poor condition. The rubberised coating has lifted away from the planking in several places. These places retained water much like a blister.
